CITY OF YUBA CITY
STAFF REPORT

Subject: Stop Sign and Crosswalk Installations

Stop Sign Warrant Study

Subject Intersection: Rosalind Ave and Olive St

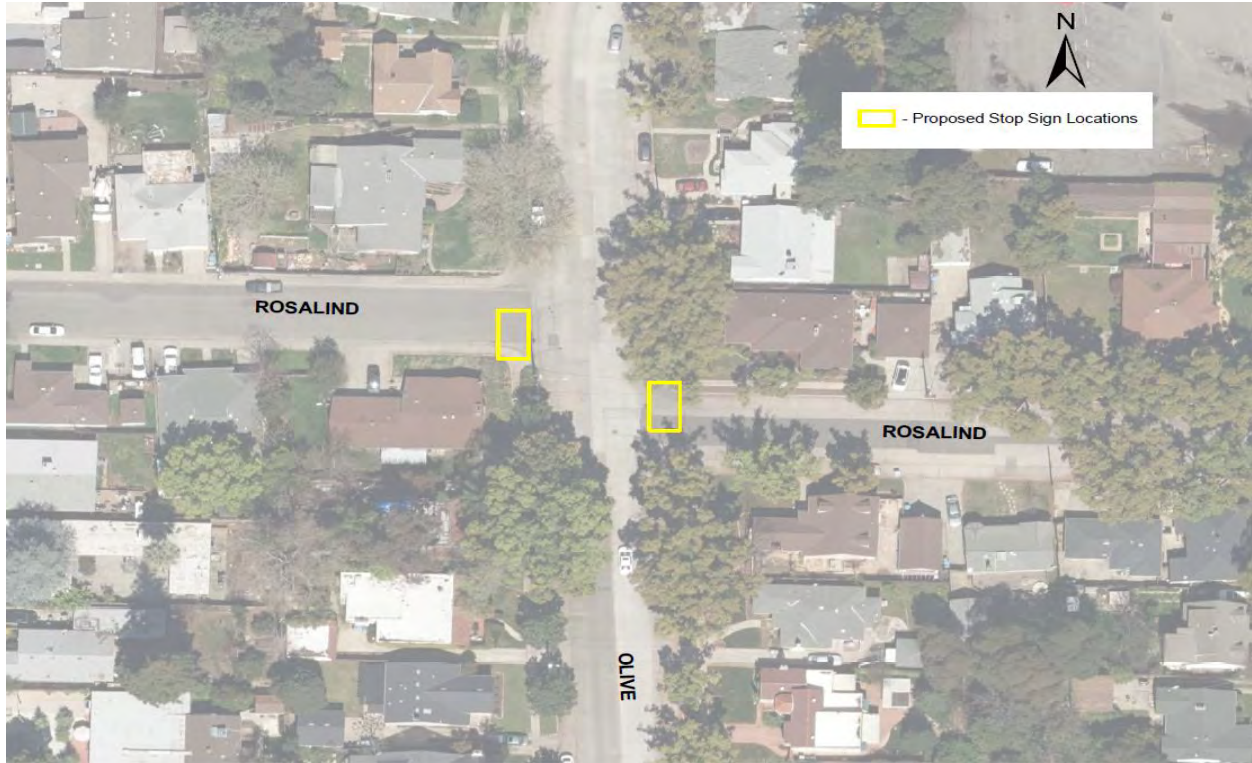
The intersection of Olive Street and Rosalind Ave is located in a residential area. Rosalind Ave does not flow straight across Olive St. the section of Rosalind Ave that is west of Olive St is approximately 65 feet north of the section of Rosalind Ave that is east of Olive St. Rosalind Ave and Clark Ave intersection has the same alignment issue and has stop signs on Rosalind Ave.

Traffic studies were conducted near the subject intersection on August 17, 2018. The 85th percentile speed for Olive Street is 30 mph, while the posted speed limit is 25 mph. There have been multiple complaints at this intersection due to vehicles not safely merging from Rosalind which does not have a stop sign. Olive Street is also lined with large trees that create a visibility issue for cars trying to turn on Olive St from Rosalind Ave. The restricted view and safety issues are susceptible to correction through the installation of a stop sign on Rosalind Ave.

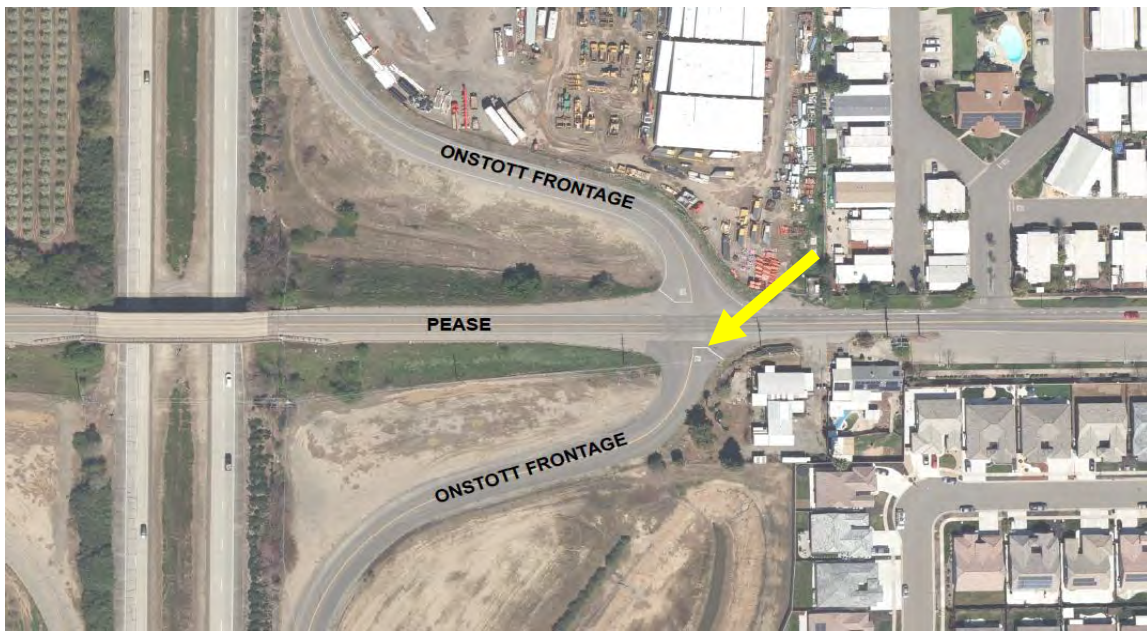
Location:

The intersection of Pease Road and East Onstott Frontage Road is near a residential area to the south, and a school zone and industrial area to the north. Yuba College's Sutter Campus is north of the intersection on East Onstott Frontage Road. Pease Road is classified as a collector street and is on the outskirts of the

City limits. The posted speed limit for Pease Road west of the intersection is 40 mph. East of the intersection is a mobile home park and Pease Road has a speed limit of 30 mph. The intersection has had increased traffic to and from Yuba College's Sutter County Campus. There is a cross traffic ahead sign and flashing beacon for the eastbound direction on Pease Road. A stop ahead sign will replace the cross traffic ahead sign and the flashing beacon will still be installed to notify eastbound drivers of the impending all-stop intersection.

A Traffic Study was conducted near the subject intersection on July 10 & 26, 2018. There is no existing traffic control for the vehicles travelling on Pease Road. The 85th percentile speed for Pease Road west of the intersection is 47 mph, whereas east of the intersection the 85th percentile speed is 46 mph. Collision history for the subject intersection includes 6 broadside collisions since 2008. Vehicles travelling north and south on East Onstott Frontage Road have visibility issues seeing cars to the west when trying to cross Pease Road due to the slope of the Pease Rd overpass.
